PHASE I REPORT
NATIONAL DAM INSPECTION PROGRAM

Name of Dam: SCS DAM PA-451
State & State No.: PENNSYLVANIA, 64-197
County: WAYNE
Stream: NEVIN CREEK
Date of Inspection: November 6, 1979

PHASE I INSPECTION REPORT
NATIONAL DAM INSPECTION PROGRAM

SCS DAM PA-451

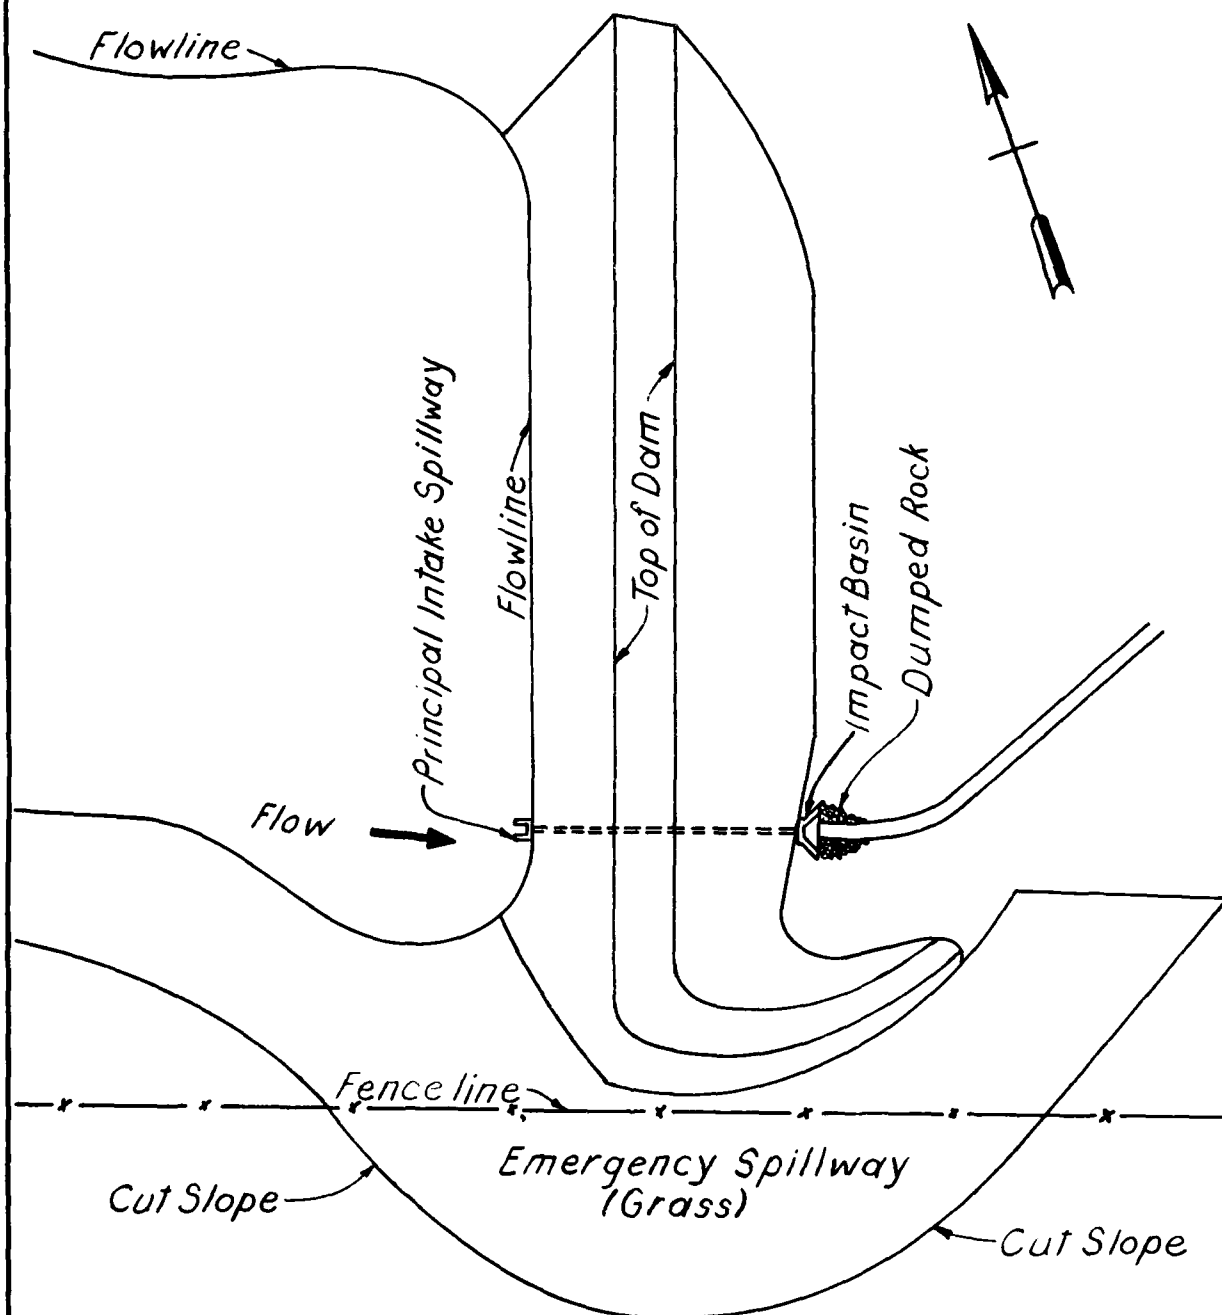
PLATE A-I

The emergency spillway in the right abutment appeared to be in good condition with a good grass mat for erosion protection. The side slopes are stable and the flow of water is directed away from the toe of dam with a spur dike constructed from soil (Appendix A, Plate A-I). The principal spillway was in good condition.

E. RIPRAP FAILURES	No riprap on exposed upstream slope. Appears stone protection below flow line.
F. JUNCTION EMBANKMENT & ABUTMENT OR SPILLWAY	Left abutment is good. Right end of embankment curves and forms left side of emergency. (Plate A-I).

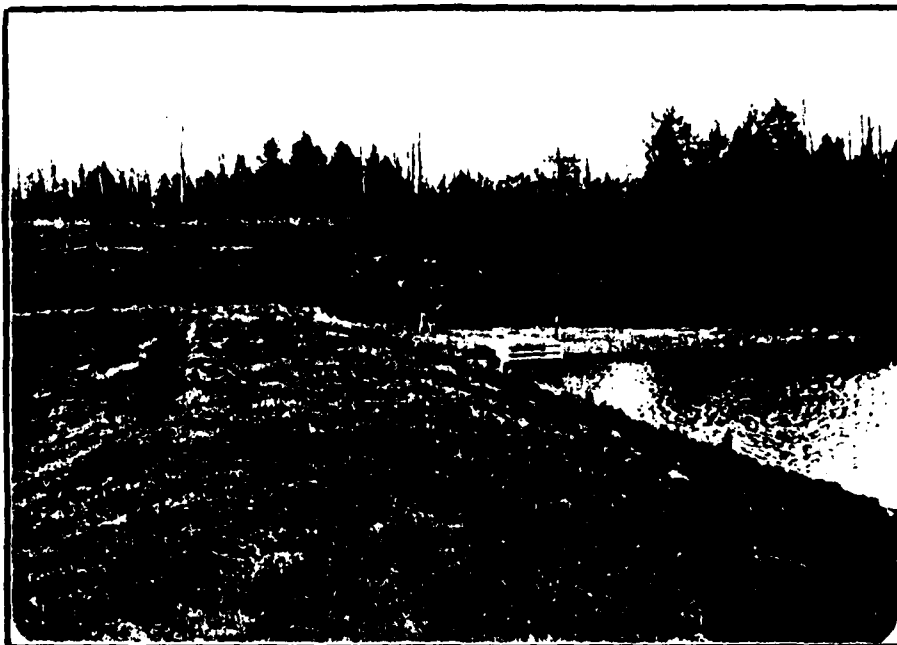
RIGHT END OF EMBANKMENT WITH DROP INLET
STRUCTURE - NOTE EMERGENCY SPILLWAY IN BACKGROUND - NO. 2

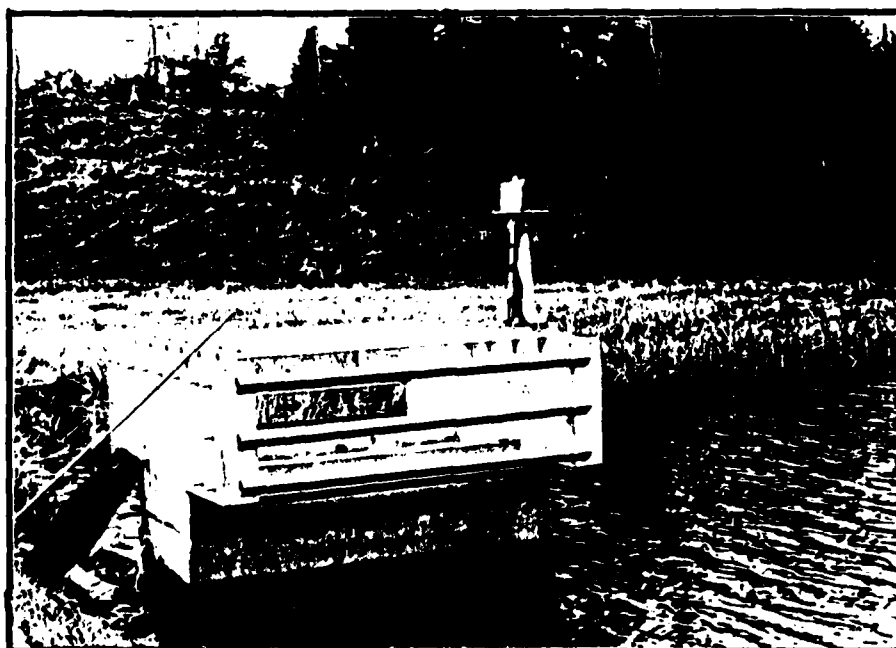
DETAIL DROP INLET STRUCTURE OR PRINCIPAL SPILLWAY - NO. 3

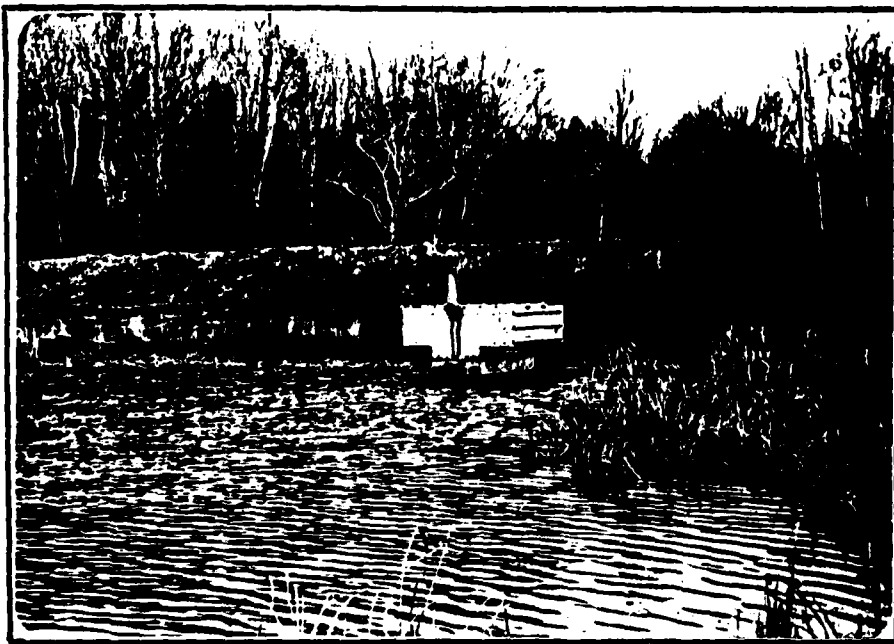
UPSTREAM SLOPE & INLET STRUCTURE - NO. 4

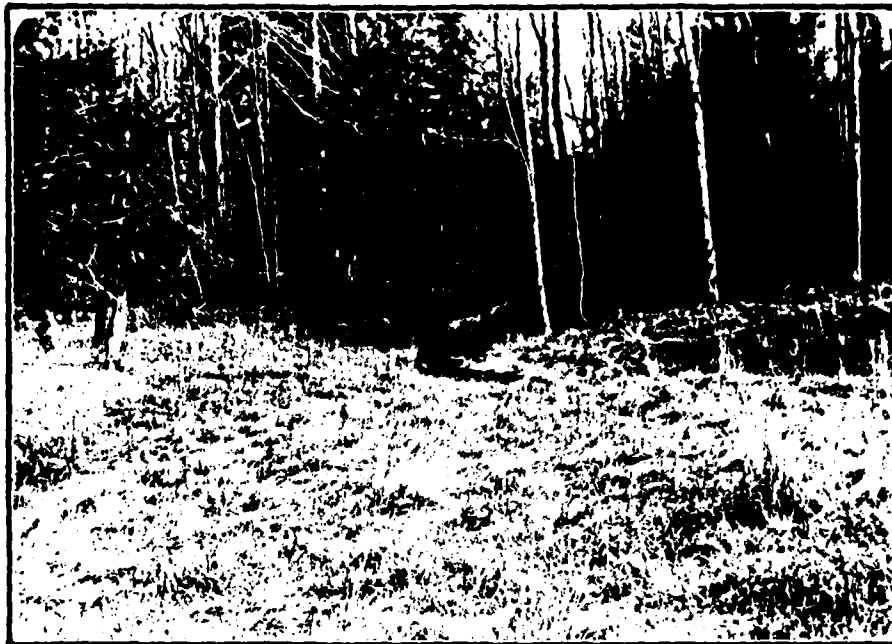
DOWNSTREAM CHANNEL - NO. 6

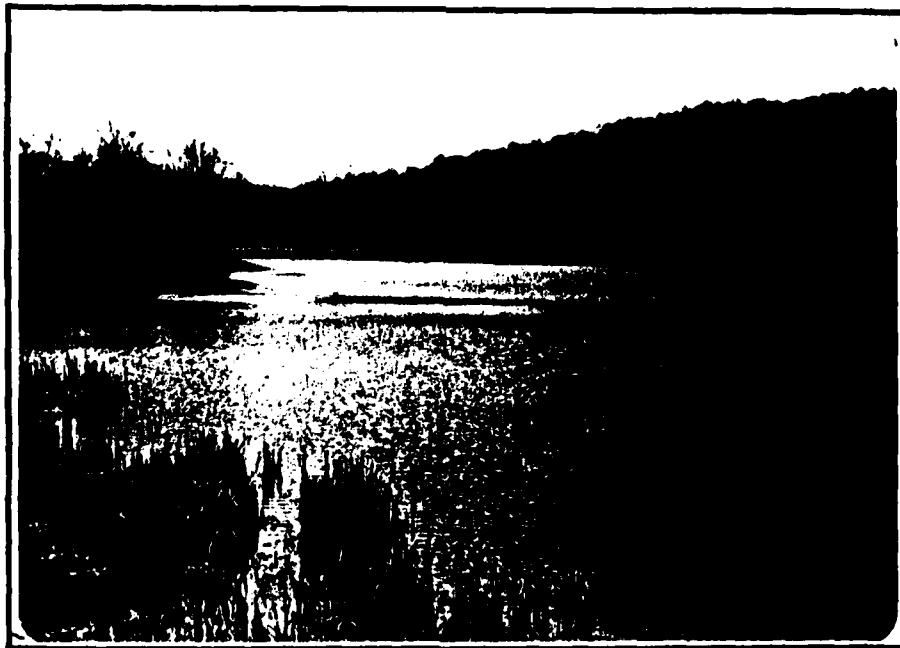
RESERVOIR AREA - NO. 9
